Manhole Inspection Summary

Manhole # S150__039MH

Insp Date: **4/4/08 11:19 AM**

Location Address: **2709 frederick av**

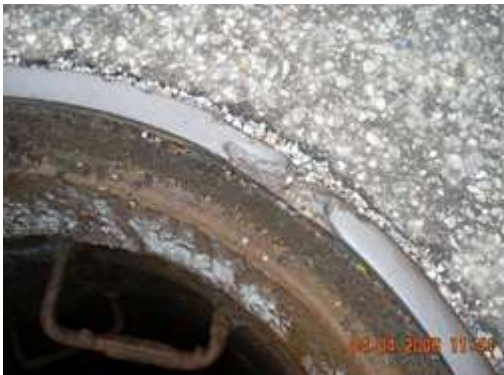
Defect 2

☒ **Cracked**

☒ **Leaks**

worn frame

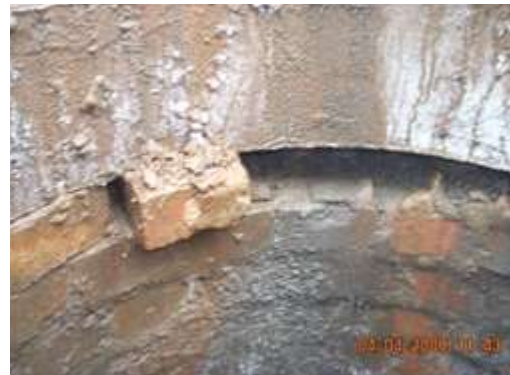
Defect 1

Condition: ☐ Sound ☐ Cracked ☐ Root Intrusion ☒ **Loose Brick** ☒ **Deteriorated**

Infiltration: ☐ None ☒ **Joint** ☐ Cracks ☐ Mortar ☐ Roots ☐ Wall

loose and deteriorated chimney bricks,
frame leaks and signs of infiltration from
chimney

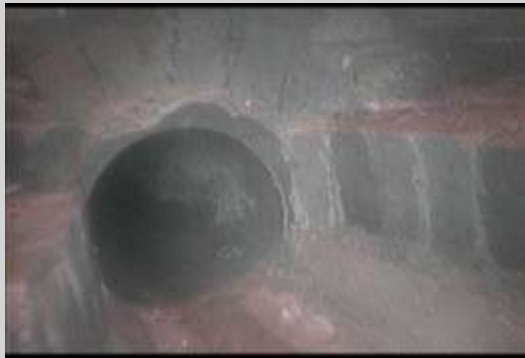
12 O'Clock Outflow

Pipe Height: **8.4** (in.) Rod and Bar (Angled)
Pipe Material: **Clay** ☐ Pipe Lined
Invert Depth: **16.30** (ft.) Flow Characteristics: **Slow**
Deposits: ☒ None ☐ Mud ☐ Sludge ☐ Debris ☐ Grease
Silt Depth: **0** (in.) Deposits Extent:
Infiltration: **None** Pipe Seal Cond: **Cracked**
